Manhole Inspection Summary

Manhole # S15A1_018MH

Insp Date: **6/30/08 10:21 AM**

Location Address: **2844 georgetown rd**

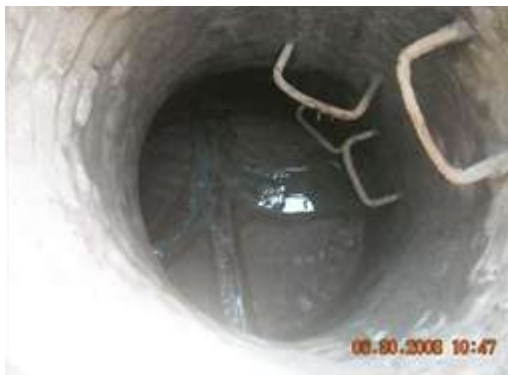
bench debris

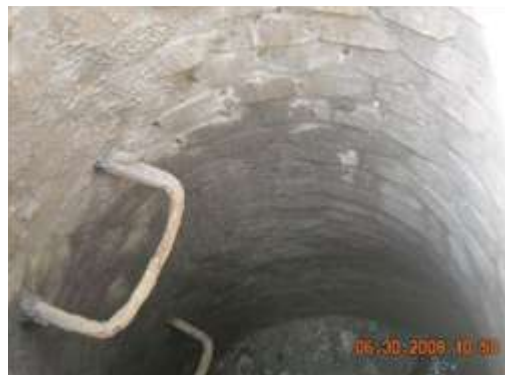
Defect 4

Infiltration: ☐ None ☐ Joint ☐ Cracks ☐ Mortar ☐ Roots ☒ **Wall**

infiltration @ corbel wall

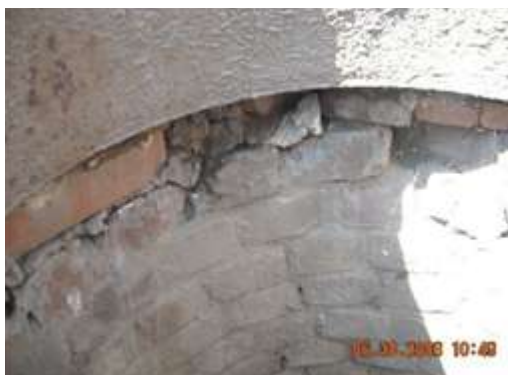
Defect 3

Condition: ☐ Sound ☒ **Cracked** ☐ Root Intrusion ☐ Loose Brick ☐ Deteriorated

cracked chimney

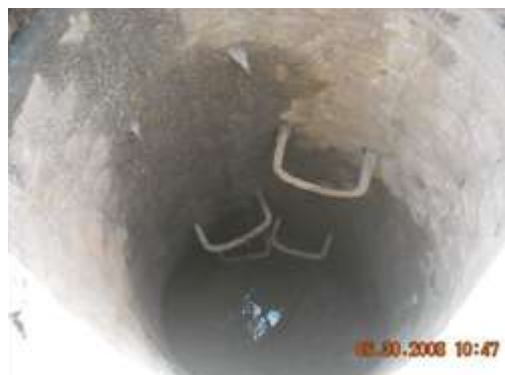
Defect 2

Count: **4** Missing: **1** ☒ **Corroded**

corroded & missing steps

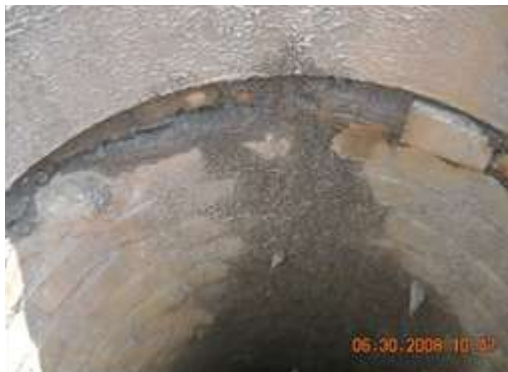
Defect 1

Infiltration: ☐ None ☒ **Joint** ☐ Cracks ☐ Mortar ☐ Roots ☐ Wall

infiltration @ chimney/frame joint

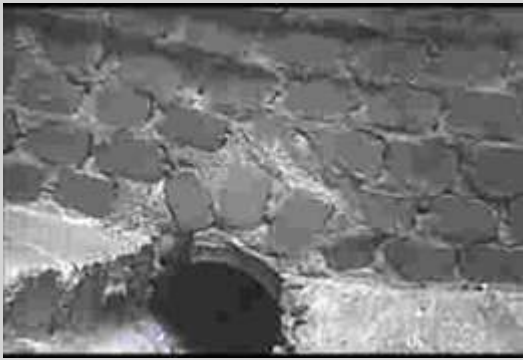
12 O'Clock Outflow

Pipe Height: **8.4** (in.) Rod and Bar (Angled)
Pipe Material: **Clay** ☐ Pipe Lined
Invert Depth: **10.28** (ft.) Flow Characteristics: **Fast**
Deposits: ☒ None ☐ Mud ☐ Sludge ☐ Debris ☐ Grease
Silt Depth: **0** (in.) Deposits Extent:
Infiltration: **None** Pipe Seal Cond: **Sound**

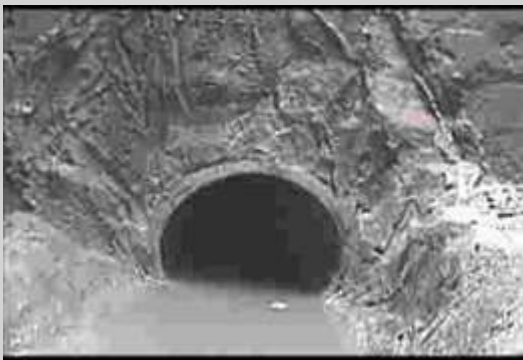
3 O'Clock Inflow

Pipe Height: **8.4** (in.) Rod and Bar (Angled)
Pipe Material: **Clay** ☐ Pipe Lined
Invert Depth: **9.75** (ft.) Flow Characteristics: **Slow**
Deposits: ☒ None ☐ Mud ☐ Sludge ☐ Debris ☐ Grease
Silt Depth: **0** (in.) Deposits Extent:
Infiltration: **None** Pipe Seal Cond: **Sound**

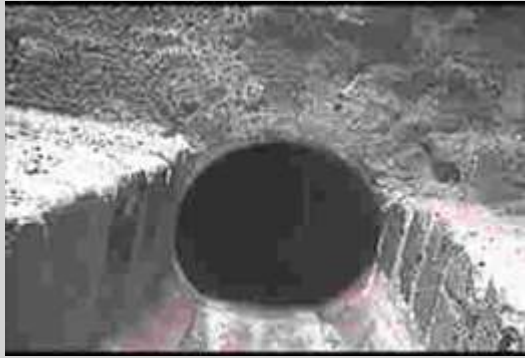
6 O'Clock Inflow

Infiltration: **None** Pipe Seal Cond: **Sound**

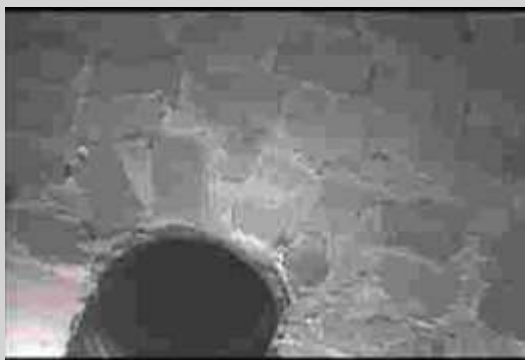
8 O'Clock Inflow

Infiltration: **None** Pipe Seal Cond: **Sound**
